## ANALYSIS OF THE DEGRADATION CONDITION OF SECONDARY SCHOOLS. CASE STUDY: PAVILIONS AND PREFABRICATED BUILDINGS

Joana BARRELAS, Jorge DE BRITO, João Ramôa CORREIA

Received 26 Apr 2013; accepted 16 Sep 2013

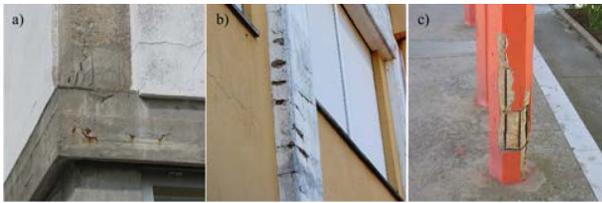
Fig. 7. Illustration of severity levels: a) level 1 – exposed concrete beam; b) level 2 – painted concrete column; c) level 3 – painted concrete column

reinforcement are considered aggravating factors (Fig. 7). After this process, the chosen level is subjected to two types of weighting factors. These factors, also organized in three levels (1.0; 0.7; 0.3), result from the ranking of the types of defects and construction elements. In terms of types of defects, level 1.0 is associated to those that tend to compromise the safety of the users and the integrity of the building, whereas level 0.3 is used for defects that affect the construction elements only superficially or aesthetically. In terms of construction elements, level 1.0 corresponds to structural elements, while level 0.3 is associated to non-structural elements, including coatings that do not compromise the safety of the users when affected by defects.
