EXPERIMENTAL AND NUMERICAL INVESTIGATIONS ON HISTORICAL MASONRY WALL SPECIMENS TESTED IN SHEAR-COMPRESSION CONFIGURATION

Franco DI FABIO, Amedeo GREGORI, Matteo TOTANI

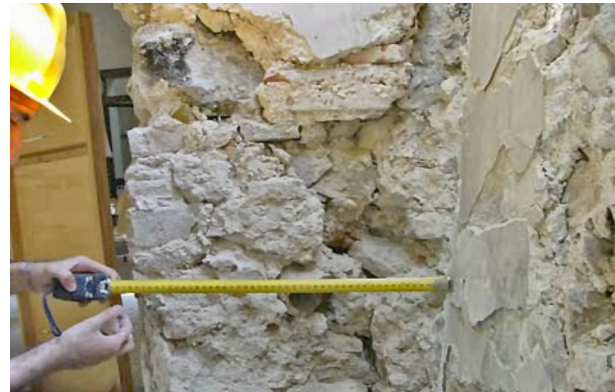
Fig. 2. Chaotic masonry texture made of irregular stone units, poor lime-clay mortar and large inclusions of bricks

From an architectural point of view, a general description of the building is provided in Ceci *et al.* (2010) and in Dominici *et al.* (2014). From a structural viewpoint, Palazzo Camponeschi's original resistant system consists of vertical masonry walls composed of irregular stone units and poor lime-clay mortar joints. Large inclusions of bricks or other low-quality materials are found in the masonry volume, so that a chaotic masonry texture is generally recognized in the building (Fig. 2).

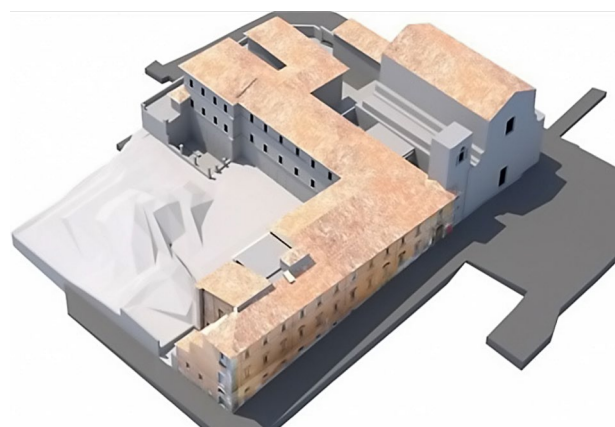
Fig. 1. Building date of constituent parts of Palazzo Camponeschi's aggregate, also including the old Jesuit's Church (on the left); rendering of Palazzo Camponeschi (on the right)

Palazzo Camponeschi is a monumental masonry building standing in the old city centre of L'Aquila. The original building plan probably dates before the 16th century, but several modifications to the original building structure were introduced in the following centuries (Fig. 1).

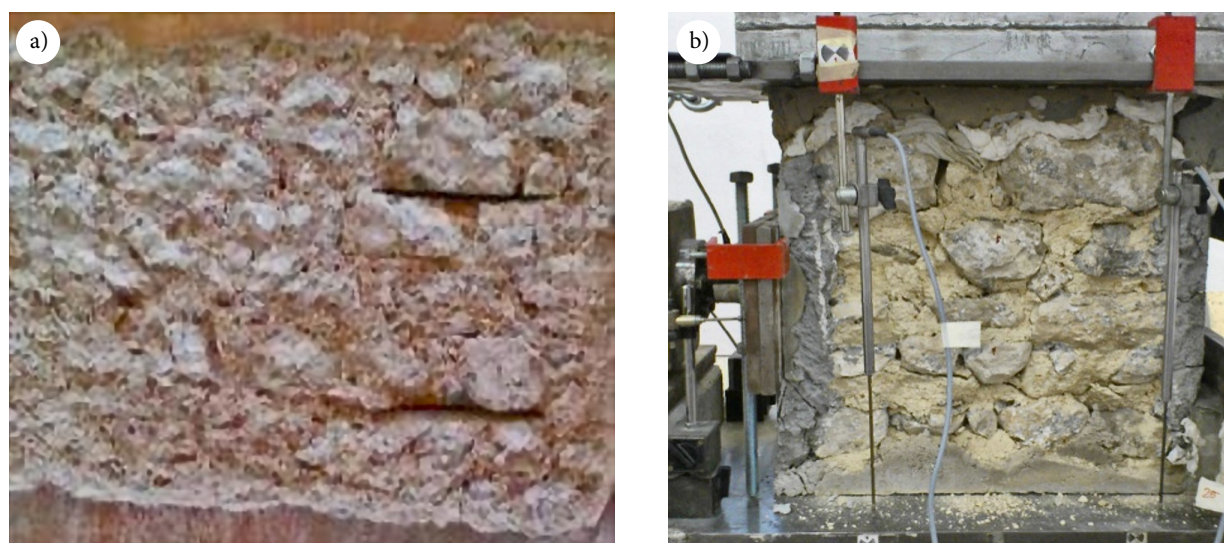
Fig. 3. The original texture of the masonry wall in Palazzo Camponeschi (a) and laboratory wall specimens reproducing it (b)

Several wall specimens about 500 mm long, 500 mm high and 300 mm thick were prepared with the original limestone elements and the constructive techniques recognized in Palazzo Camponeschi. The average diameter of the stone elements was in the 120–150 mm range. The original mortar features (characterized by being very friable with a compressive strength lower than 2 MPa) were reproduced according to the 1:2.5 ratio between commercial calcium hydroxide (in powder) and local, crashed limestone sand including large clay percentage. Water was added to the mortar mixture till a plastic consistency was reached. The original wall texture in Palazzo Camponeschi and that reproduced with the laboratory wall specimens are compared in Figure 3.

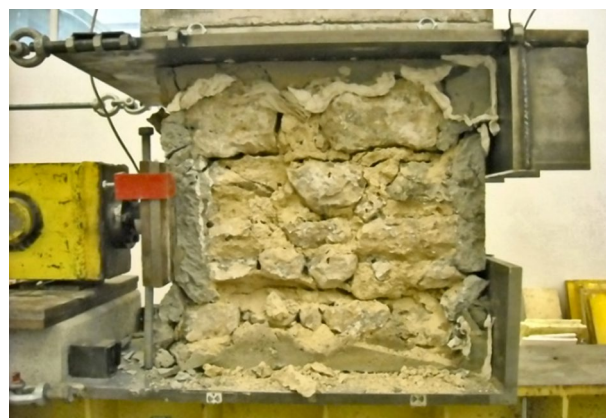
Fig. 6. Photo of a wall specimen the central portion of which is sliding with respect to the upper and lower parts

1.5 mm/min, causing the central part of the wall specimen to slide with respect to the upper and lower parts (Fig. 6). While the sliding took place, the axial load N was kept constant, and the current shear load values T were recorded together with the displacements.

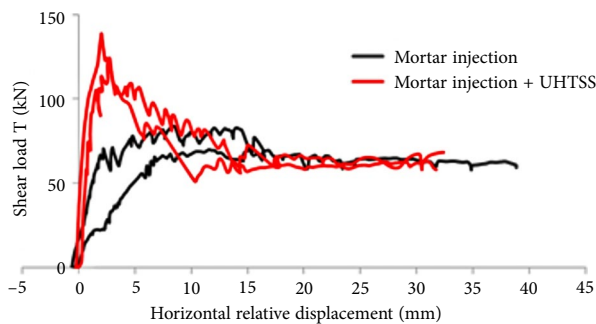
Fig. 7. Shear load vs. horizontal relative displacements recorded during the experimental tests

Figure 7 plots the values of the shear force T versus the relative displacement recorded between the central portions of the specimens and the lower part. The solid black curves refer to the wall specimens consolidated only with mortar injections. These curves exhibit a first, almost linear branch; a subsequent softening behaviour; and a final plastic horizontal tail. The two specimens reached the maximum shear force of about 65 and 75 kN respectively for a relative displacement value of about 10 mm, showing some small differences in stiffness. After the peak strength was attained, both specimens showed a plastic behaviour. The maximum

shear force recorded from the specimens remained constant even at relative displacements of 35 mm and over. Unfortunately, one of the tests had to be stopped earlier (at 17 mm) due to technical problems.

The solid red curves refer to walls specimens consolidated with mortar injection and reinforced with UHTSS. Compared to the unreinforced specimens, the use of external reinforcements provided much higher strength and stiffness. The two wall specimens reinforced with UHTSS reached the maximum shear strength values of about 125 kN and 140 kN respectively. Since these shear peak values were recorded at the relative displacements of about 3 mm, wall specimens reinforced with UHTSS resulted to be about six times stiffer than the unreinforced wall specimens.

The post-peak behaviour of the specimens reinforced with UHTSS was characterized by a long softening branch, with the shear force quickly reducing towards a residual final value. This residual shear strength value was found to be similar to the maximum shear strength measured on masonry wall specimens consolidated with injection and not reinforced outside. This mechanical behaviour of the specimens reinforced with UHTSS was found to depend on the progressive delamination process occurring in the outer reinforcement. Once the maximum shear strength of the reinforced specimens is reached, the outer reinforced layer starts detaching from the wall becoming progressively more and more unstable in their plane. At the end of this process, when the reinforced layer is completely lost on both sides of the specimen (Fig. 8), the strength capacity of the specimen approaches the corresponding value of the unreinforced specimen.

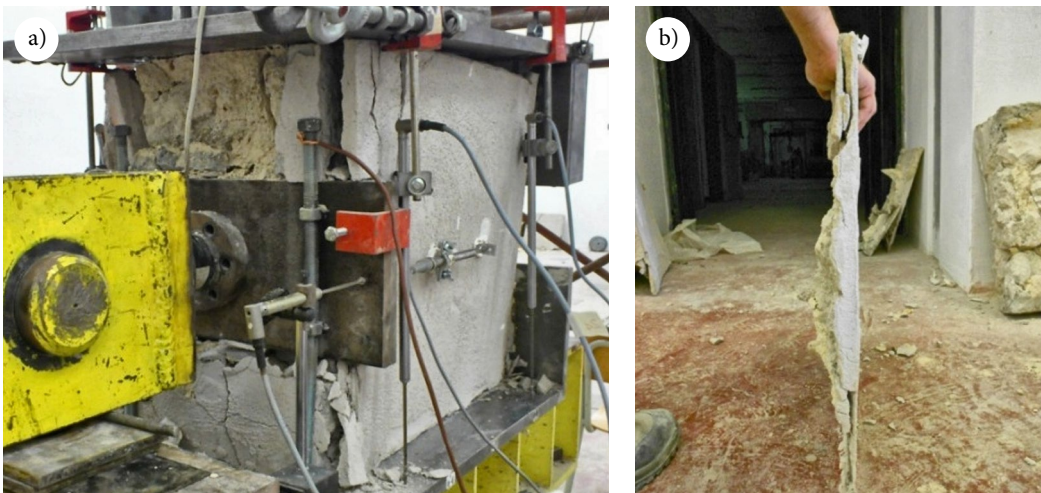
Fig. 8. External reinforcements delaminated from wall specimens

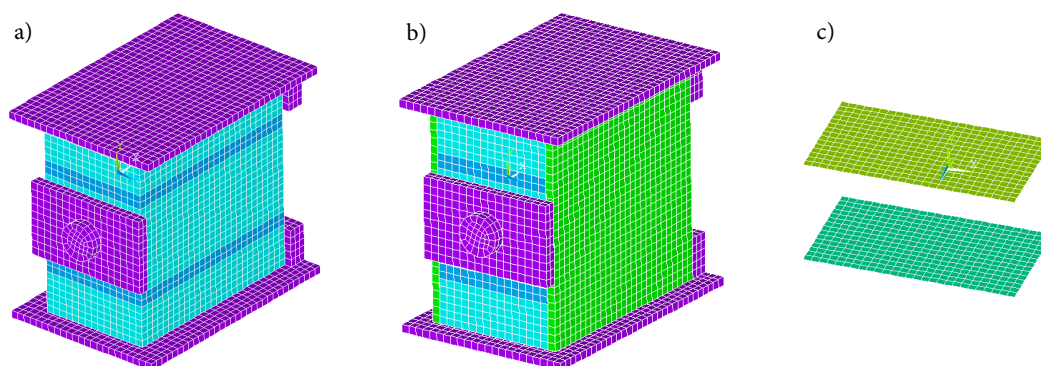
Fig. 9. FEM of the unreinforced wall specimen (a); FEM of UHTSS reinforced specimen (b); contact plane elements at the interfaces of the three parts of the wall specimen (c)

In order to reproduce the experimental tests and to better understand the debonding failure mechanism of the external reinforcement, a nonlinear Finite Element Model (FEM) was implemented in ANSYS code v.13.0. The model is shown in Figures 9a and 9b, where the masonry specimen is represented in cyan, the testing apparatus in purple, and the mortar of the external reinforcement in green colour.

The elements near the sliding surfaces, represented in blue colour in Figure 9a, had $E = 500$ MPa to account for the cracking phenomenon of the mortar joints where the sliding occurred, according to experimental evidence (Fig. 6).

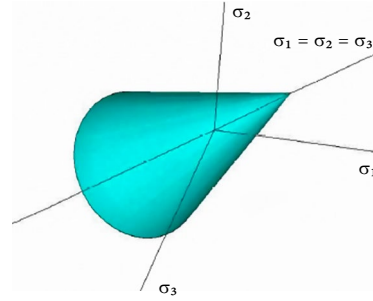
Fig. 11. Drucker-Prager surface in the principal stress space

shape of cone with right meridians (Fig. 11): when the stress state reaches the DP surface, plastic deformation occurs with constant stress level.

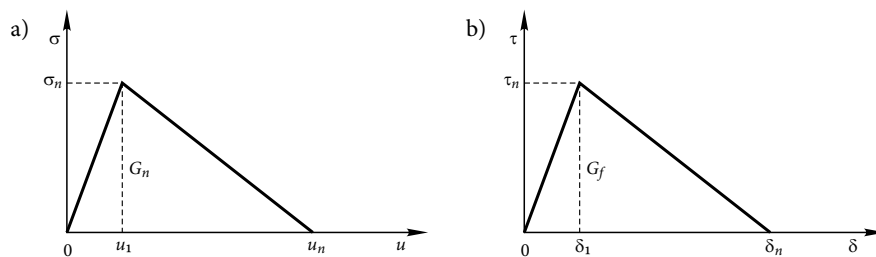
Fig. 10. Bilinear cohesive laws adopted for the separation and the sliding behaviour

Solid 185 type (three-dimensional eight nodes isoparametric) elements have been used to schematize the masonry and testing apparatus. Since the experimental failure mechanism occurred due to the sliding of the central part of the specimen with respect of the upper and lower parts, the specimen was divided into three parts separated by two sliding surfaces. The bond between the three parts was modelled through contact plane elements (Targe 170, Conta 174) placed at their interfaces (Fig. 9c). Using these elements, several contact laws can be assumed. In this case, a bilinear cohesive law was assumed, allowing the separation and the slip of the contact surfaces in accordance with the bilinear model plotted in Figure 10. In this model σ and τ are the normal and the shear contact stress respectively, u and δ are the contact gap and the tangential slip between the two planes. The constitutive interface model shows a first linear loading behaviour that is followed by linear softening branch, meaning that when the maximum normal contact stress σ_n is achieved, a separation begins. This separation is completed when the contact gap reaches u_n . Similarly, when the shear stress τ_f is achieved, delamination occurs and ends when the relative displacement reaches δ_f for which the shear stress is zero. The areas G_n and G_f in Figure 10, defined as the critical fracture ener-

The bond-separation and bond-slip relationships are defined by σ_n , G_n , τ_f and G_f (Fig. 10). The value assigned to σ_n was 0.12 MPa, equal to the masonry tensile strength calculated as $f_t = 0.1f_c$, and a low value of 0.01 N/mm was assigned to G_n in order to confer a brittle separation behaviour.

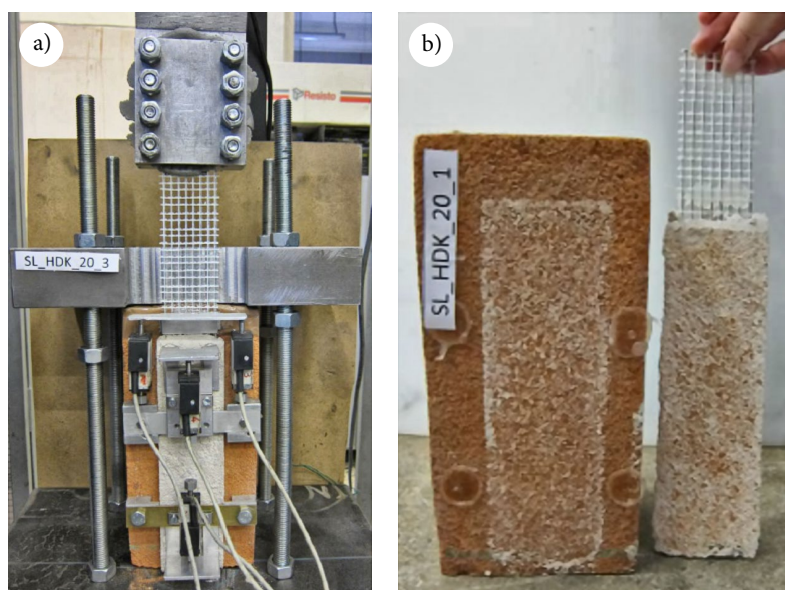
Fig. 12. Direct shear test described in manufacturer's report (a); failure mode of a test (b)

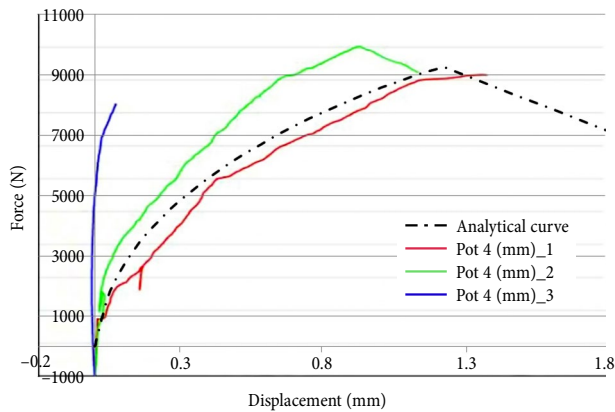
Fig. 13. Force-displacement curves of direct shear tests and of numerical solution

The numerical solution provided a force-displacement curve of the shear test that was in good agreement with the experimental curves (Fig. 13).

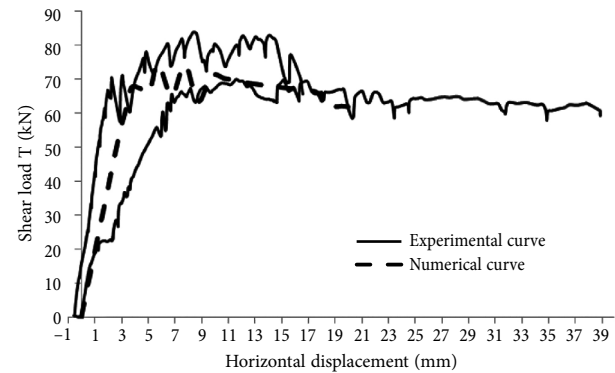
Fig. 15. Nonlinear analysis results from FEM reproducing walls specimen reinforced with mortar injections only: load-displacement curve compared to experimental curves

Figures 15 and 16 show the load-displacement curves resulting from the analysis of the specimen reinforced with mortar injection only and in combination with

UHTSS, respectively. A good numerical-experimental agreement can be noticed: the maximum shear force and the displacements compare quite well. The numerical analyses stopped due to convergence problems. The curves are characterized by a loss of stiffness when sliding begins. Figure 17 shows the contour of the contact shear stress along the interfaces among the three parts of the unreinforced wall specimen. Sliding began when the shear stress reached the value of 0.230 MPa: the blue zones, where stress values are close to zero, are the detachment areas due to normal separation of the surfaces. The maximum load was reached when the shear stress attained τ_f over the entire contact surfaces.

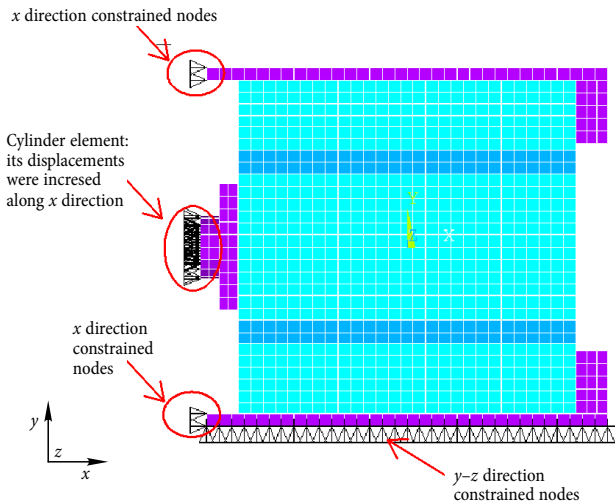
Fig. 14. Displacements and constraints applied to the nodes of the model

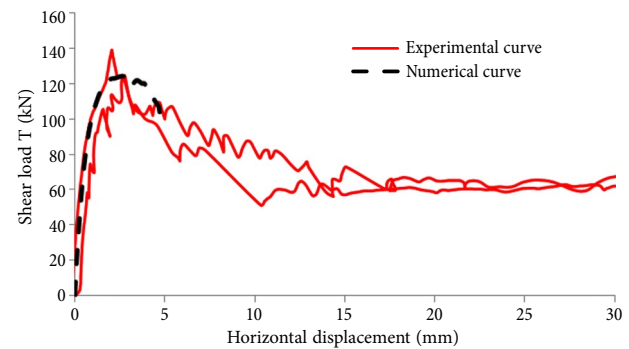
Fig. 16. Nonlinear analysis result from FEM reproducing specimen reinforced with mortar injections and UHTSS: load-displacement curve compared to experimental curves

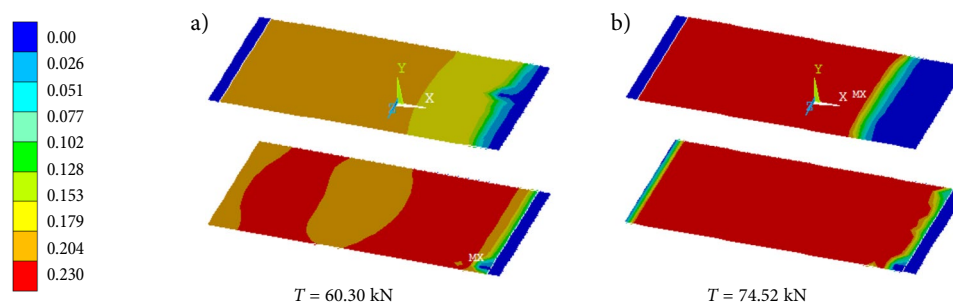
Fig. 17. Contact shear stresses, expressed in MPa, along sliding surfaces for two values of shear load

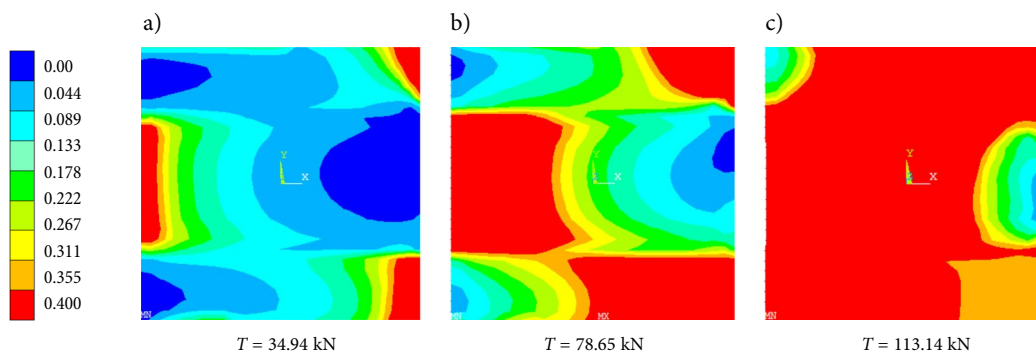
Fig. 18. Contact shear stresses, expressed in MPa, on sliding mortar-masonry interface for three values of shear load

The model of the UHTSS reinforced specimens revealed that the failure mechanism of the reinforcement was its loss of adhesion from the wall specimen. Debonding started near the steel plate transferring the load and near the vertical supports (red areas in Fig. 18a). Debonding zones gradually increased with shear load, until almost all the mortar-masonry interface reached the contact shear stress $\tau_f = 0.4$ MPa (Fig. 18c).
