SYSTEMATIC METHOD FOR MONITORING AND EARLY-WARNING OF GARDEN HERITAGE ONTOLOGY USED IN THE SUZHOU CLASSICAL GARDEN HERITAGE

Abstract. Taking garden heritage ontologies as the object, this paper explores monitoring and early-warning methods of heritage based on fuzzy cluster analysis. A monitoring and early-warning system for garden heritage ontologies is designed and consists of monitoring indexes, a monitoring program, monitoring data collection, application of an early-warning grading evaluation model and conclusion of early-warning grading. Taking the Suzhou classical garden heritage as an example, it can be concluded that the systematic method can integrate various qualitative and quantitative index values and collectively reflect the overall state of garden heritage ontologies as well as match a heritage monitoring ontology with an early warning grade by calculating the data similarity matrix, membership matrix, fuzzy similarity matrix, fuzzy equivalent matrix and cut matrix. Five kinds of heritage ontologies with a total of twenty-seven heritage monitoring indicators are applied in the model and then be matched with MATLAB software to obtain accurate early-warning results. W

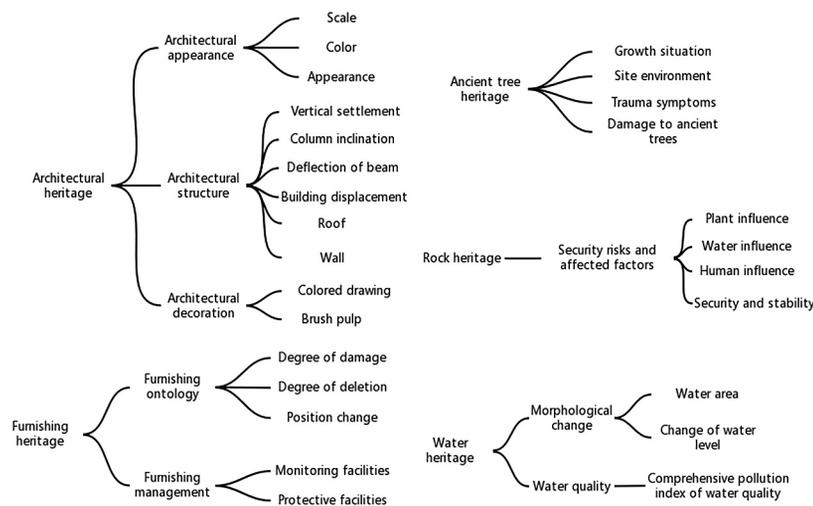
According to differences in building appearance, building structure, and building decoration, there are 11 monitoring indicators related to buildings, such as vertical settlement, column inclination, deflection of beam, and building displacement. Monitoring indicators of garden rocks focus on safety and affected factors. The indicators include plant influence, water influence, human influence, and security and stability of the rocks. Monitoring indicators for ancient trees include growth situation, site environment, trauma symptoms, and the degree of damage. Water monitoring indicators include changes in water form and quality. Monitoring indicators for furnishings are divided into 5 categories according to furnishings and management. All indicators are shown in Figure 1.

Figure 1. Monitoring indexes of garden heritage

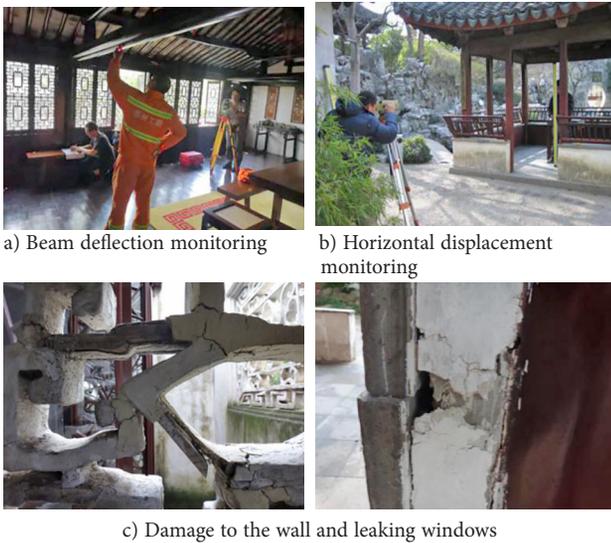
Deformation monitoring includes monitoring the vertical settlement, horizontal displacement, column inclination,

Figure 2. Building Structural Monitoring

and beam deflection. It must be carried out strictly in accordance with the Code for Measurement of Building Deformation. Vertical settlement monitoring uses precise level measurement methods, and settlement monitoring points are placed under the pillars of each building. The adjustment control software Nasew V3.0 (Sunwaysurvey, Beijing, China) of the engineering control network was used to carry out rigorous adjustment calculations, and the elevation values for each settlement monitoring point were obtained. Vertical settlement of monitoring points is the difference between this monitored elevation value and the last monitored elevation value. Horizontal displacement monitoring is performed by the total station polar coordinate method; several monitoring points are arranged on each building, and each monitoring point is arranged on a column. Column tilt monitoring is monitored by using a hanging plumb line, and the amount of architectural tilt can be determined based on its deviation value. Deflection is the bending value of a garden building and its components in a horizontal or vertical direction. Beam deflection monitoring uses a total station to directly measure the elevation of each nail root and takes the difference between average elevations of two ends and elevation at the middle. Figure 2 shows beam deflection, horizontal displacement monitoring, and damage to the wall and leaking windows.

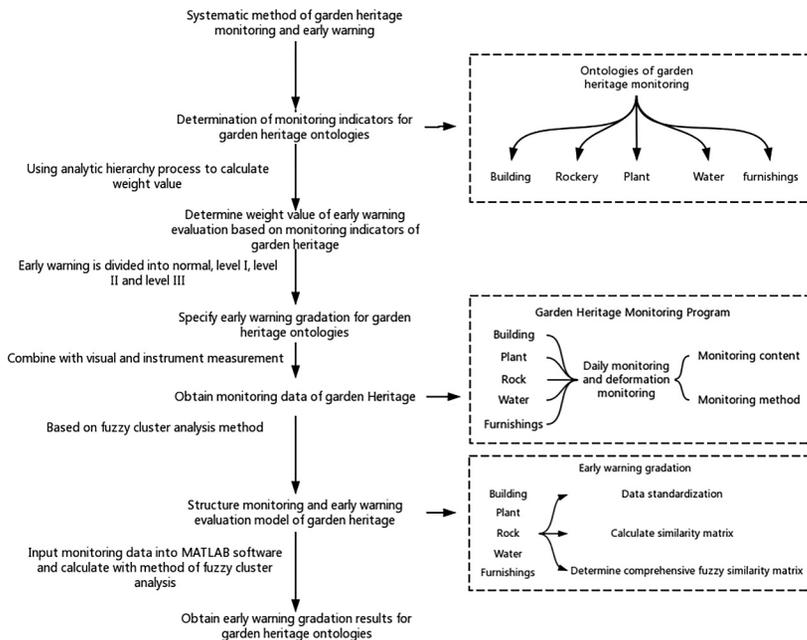
Indicators of heritage ontology at garden heritage sites are monitored. Combined with monitoring data, based on early-warning evaluation standards and index weights, and quantified and standardized monitoring data, the early-warning grading evaluation model was applied and MATLAB software was used for calculations, leading to a systematic method of garden heritage monitoring and early warning, as shown in Figure 3.

Figure 3. Garden heritage monitoring and early warning system

The garden heritage monitoring and early-warning system involves five kinds of heritage ontology, for a total of twenty-seven heritage monitoring indicators. Considering the large number of monitoring objects at a heritage site and the monitoring results for many years, a large amount of monitoring data is available. These data can be fully combined with the heritage monitoring and early-warning system, undergo scientific analysis, and then be matched with MATLAB software, to obtain accurate early-warning results.

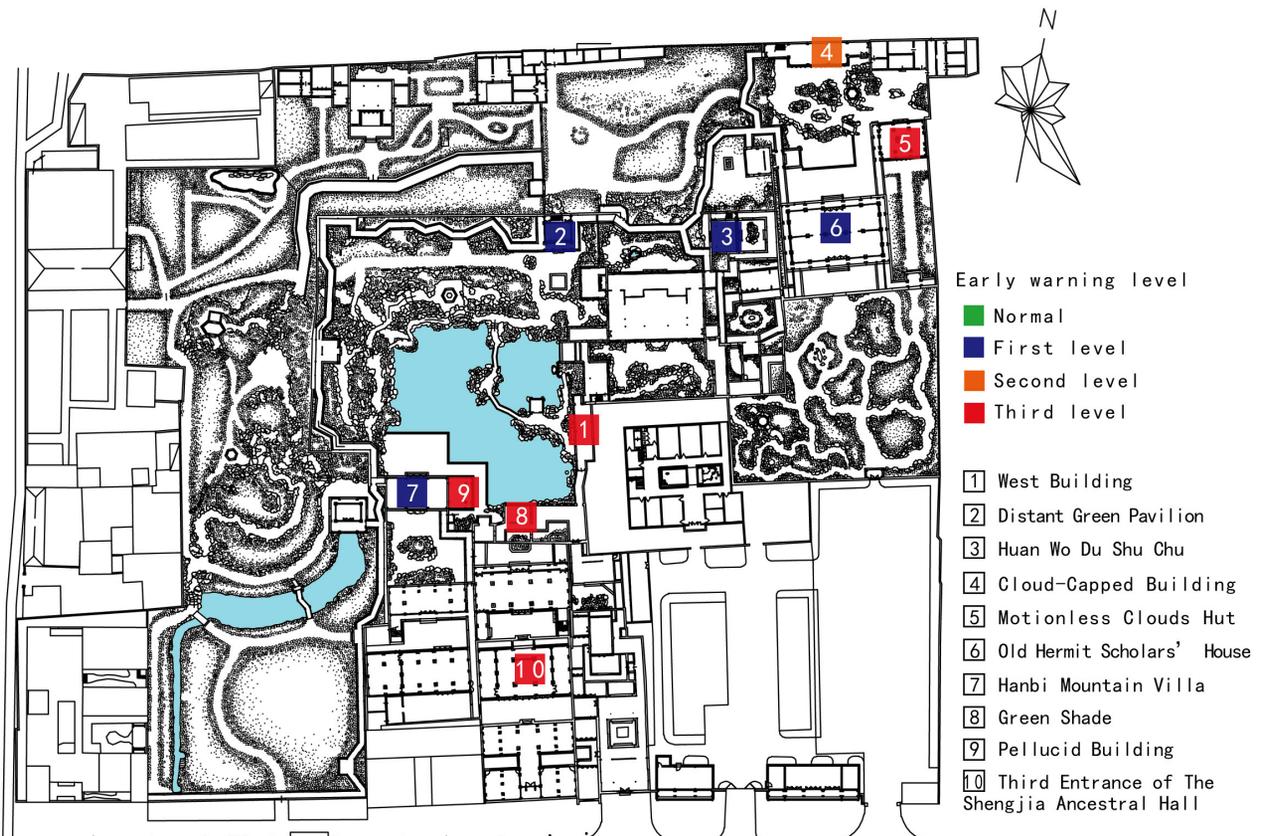
Figure 4. Early warning level of garden architecture heritage in the Lingering Garden

Taking all garden architecture in the Lingering Garden and Garden of Cultivation as the object, a spatial distribution map of early-warning grade was obtained, as shown in Figure 4 and Figure 5.

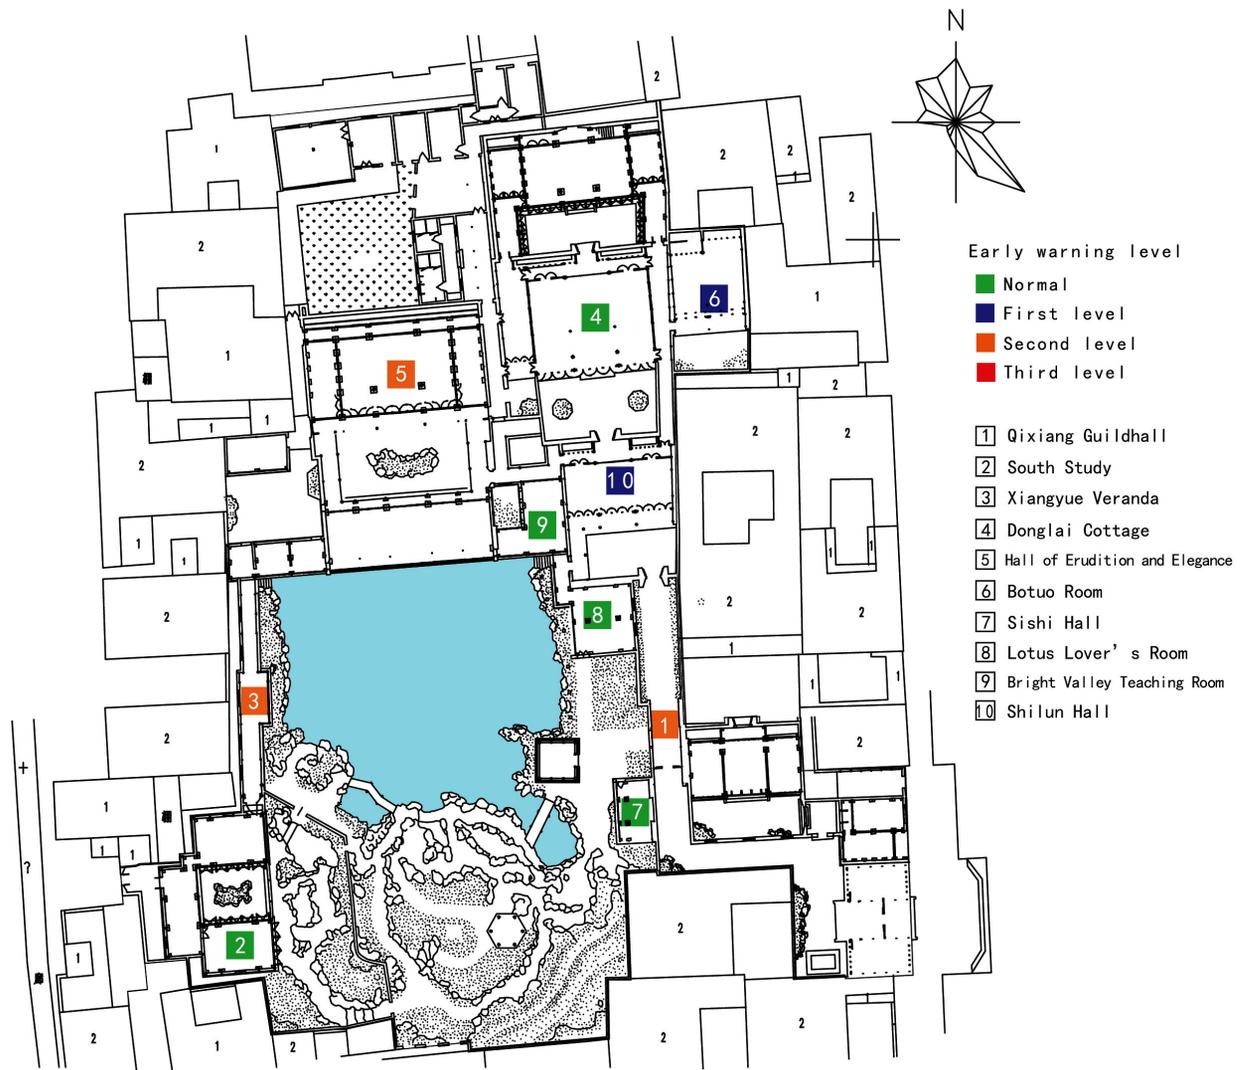
Figure 5. Early warning level of garden architecture heritage in the Garden of Cultivation

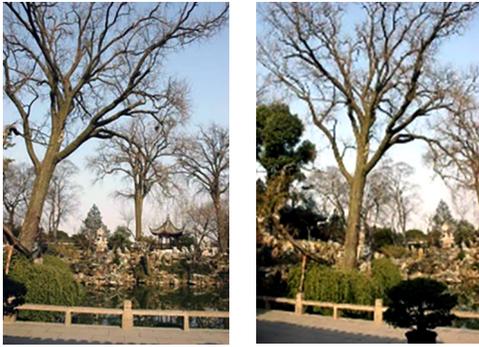
Figure 6. The *Ginkgo biloba* Linn. obliquity is obvious in the middle of the Lingering Garden

The archive of ancient trees in the Lingering Garden and Garden of Cultivation are shown in Table A10 of Appendix. Among them, No. 002# and 003# *Ginkgo biloba* Linn. was obviously tilted (Figure 6), and the growth of *Platycladus orientalis* (Linn.) and *Podocarpus macrophyllus* (Thunb.) Sweet was weak.
