# ANALYSIS OF STRAIN STATE AND CRACKING OF COCNRETE SLEEPERS

Aidas JOKŪBAITIS, Juozas VALIVONIS, Gediminas MARČIUKAITIS

*Department of Reinforced Concrete and Masonry Structures, Faculty of Civil Engineering,*
*Vilnius Gediminas Technical University, Saulėtekio al. 11, 10223, Vilnius, Lithuania*

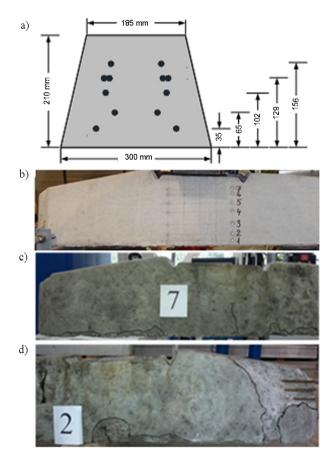
Fig. 2. Prestressed concrete sleepers: a) cross-section; b) new sleeper; c), d) used sleeper

Sleepers were inspected before testing. There was no major cracking observed in new sleepers (Fig. 2b) except for micro-cracks on the surface of concrete. It formed during the manufacturing stage due to concrete shrinkage. The used sleepers had a crack beneath the rail seat propagating from the bottom of the sleeper towards the rail seat (Fig. 2c). Crack widths of the sleeper cross-section

were 0.02–0.06 mm at the bottom and 0.005–0.03 mm – 15 mm from the bottom. Crack height reached about a half of sleeper height at the rail seat section. Some of used sleepers had cracks at the end of the sleeper, spalled peaces of concrete and uncovered reinforcement (Fig. 2d). No major cracking was observed in the middle of new and used sleepers. Therefore, the rail seat section of the sleeper was the object of the experimental research.

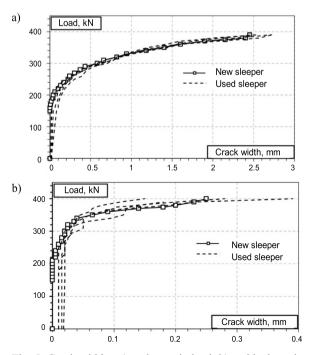
Fig. 5. Crack widths: a) under static load; b) residual crack width

Experimental results showed that the crack widths of the used prestressed concrete sleeper were greater or almost equal to the crack width of new sleepers (Fig. 5a). The difference at the level of the maximum load was 2–11%. As for new and used sleepers, load-crack width relationships were similar from 0.5 mm crack width up

to the failure of specimens (Fig. 5a). Before, the crack widths of used sleeper increased faster due to the initial pre-cracking. Residual crack widths in used sleepers did not propagated at the levels of the lower load and strated increasing at a load of 190–280 kN (Fig. 5b), which means that during the exploitation of the railroad track, these loads could occur and induce the cracking of the rail seat section. The difference between residual crack widths at the levels of maximum load varied between 1.4–2.6 times (Fig. 5b). The scatter of the results can be influenced by the aggregates and pieces of the crushed concrete changing a position in the crack during loading and unloading specimens.

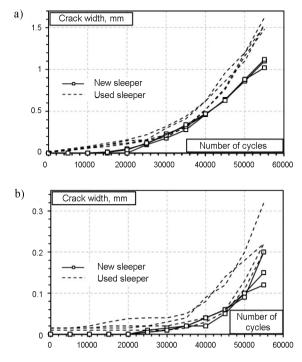
Fig. 7. *w-N* relationships: a) crack width under dynamic load; b) residual crack width

Figure 7 shows the dependence of crack width ($w$) versus the number of load cycles ($N$) at the rail seat section of new and used sleepers. The results of sleeper tests under the dynamic load showed that crack widths of used sleepers were higher comparing with those of new sleepers (Fig. 7a). The difference between crack widths appeared at the beginning of the test on the dynamic load due to the initial precracking of used sleepers. Cracks in used sleepers propagated more rapidly in the first couple of load steps up to 20,000 load cycles. However, difference between crack widths of new and used sleepers decreased between 25,000–35,000 load cycles and at some point in this region became equal. At higher load amplitudes from 40,000 load cycles, the degradation of the rail seat section of used sleepers was faster and crack widths propagated more rapidly up to the failure of specimens. The difference between crack widths of new and used sleepers before failure was 27–37%. However, the variation of the results of residual crack widths after the dynamic load was larger (Fig. 7b). The difference between residual crack widths of the new and used sleeper was up to 2.7 times.

Load-crack width relationship (Fig. 7) corresponded to load-concrete tensile strain relationship (Fig. 8) at the

rail seat section of the new and used sleeper. Concrete tensile strain of used sleepers was significantly higher than that of new sleepers and difference varied from 1.5 up to 2 times. Concrete compressive strains in used sleepers were varying. The scatter of the results can be explained by the failure mode and a different level of damage of used sleepers. Sleeper UD6_2 failed due to the slippage of reinforcement followed by reinforcement rupture. Compared with new sleeper, it caused 1.8 times lower and 1.5 times higher concrete compressive and tensile strains, respectively. Concrete compressive strains in other used sleepers were approximately equal or 1.5 times higher than new sleepers. Concrete tensile strains propagated more rapidly in used sleepers than those in the new ones (Fig. 8). It was influenced by initial damages of used sleepers during exploitation on the railroad track, which caused residual strains in concrete.

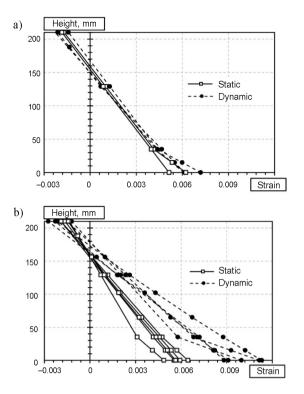
Fig. 10. Concrete strains at the cross-section of the rail seat: a) new sleepers; b) used sleepers

Comparing experimental results under static and dynamic loads concrete strains were analysed up to the selected level of the force (330 kN) at which the last measurements were taken during the dynamic test (Fig. 10). Concrete compressive and tensile strains of new sleepers were approximately equal (Fig. 10a). In contrast, concrete tensile strains of used sleepers were higher under the dynamic load up to 2,3 times comparing with the results of the static test (Fig. 10b). This is conditioned by the initial pre-cracking of the sleeper during exploitation on the railroad track. The dynamic load had an additional negative impact on the degradation of the rail seat section. It caused stress concentration in the cracked zone of the concrete sleeper during cyclic loading. Due to bond failure in the crack, friction between concrete and reinforcement appears in the tension zone of the rail seat section and gradually weakens reinforcement during cyclic loading. Reinforcement was bending under a slightly higher angle at the edges of concrete in the crack. The lower is the stiffness of the sleeper the higher is the bending angle of reinforcement during cyclic loading. A part of reinforcement in the crack was degrading more than in other parts.

In some sleepers, the distribution of concrete strains in the cross-section of the rail seat was not linear (Fig. 10). Concrete tensile strains were higher in the protective layer of concrete. This effect can be explained by the influence of concrete cracking. The main crack was propagating and the tension zone of concrete was devided in blocks. When the main crack was propagating in height and width, secondary small cracks appeared in

concrete blocks that did not reach the height of reinforcement. Additional cracks increased tensile strains in the protective layer of concrete and caused strain deviation from linear distribution.

Experimental results showed that a lower height of the concrete compression zone was found in used sleepers under the dynamic load (Fig. 10b). This means that cracking in the tension zone of the rail seat cross-section was propogating and the stiffness of the sleeper was decreasing more rapidly under the dynamic load. Therefore, dynamic loads are more dangerous than the static ones, which causes more damage to the sleeper.
